1-5/8 EIA Mating Durability Test Report

Test & characterize the mating durability of a TRU manufactured 1-5/8 EIA interface using phosphor bronze contact over an extended number of mating cycles to simulate a lifetime of performance. The test will measure and monitor the following parameters: VSWR, insertion loss, flare diameter of contact, to determine their impact on electrical/ mechanical performance.

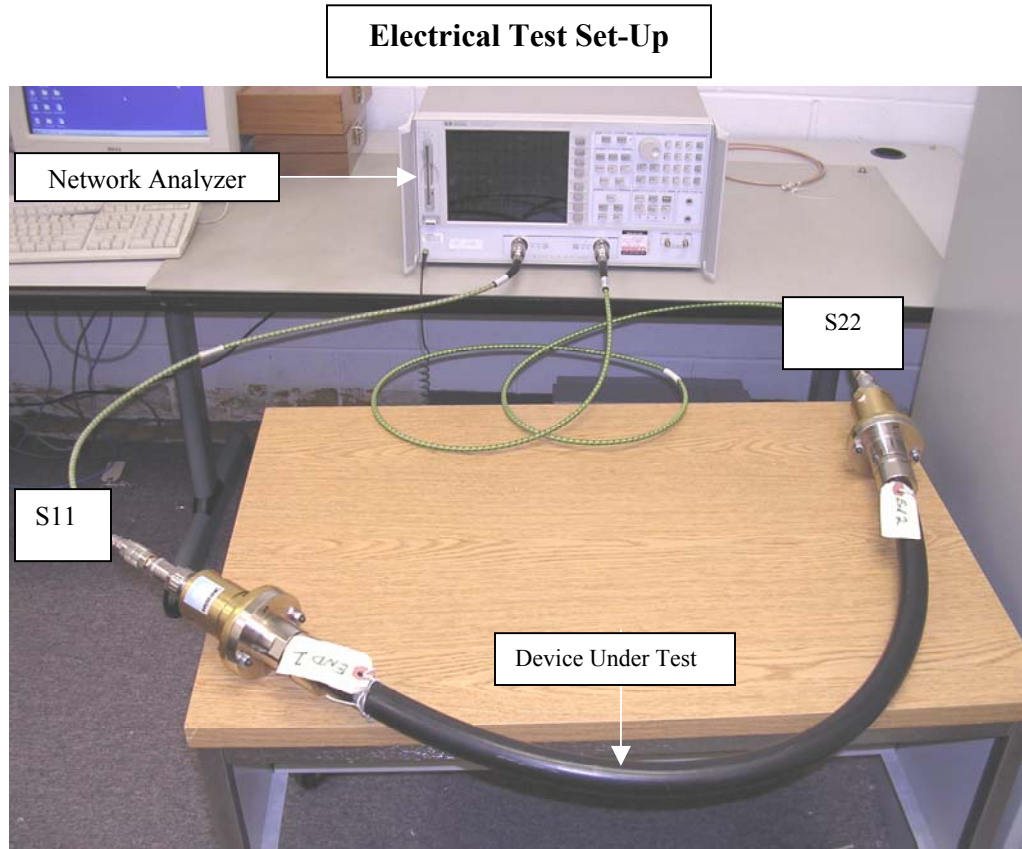
Figure 1

1-5/8 Cable Assembly: 41.50" length, LMR-1200 FR cable, Fig.1

Applicable test port cables / adapters for each assembly, set up as applicable per figure 1.

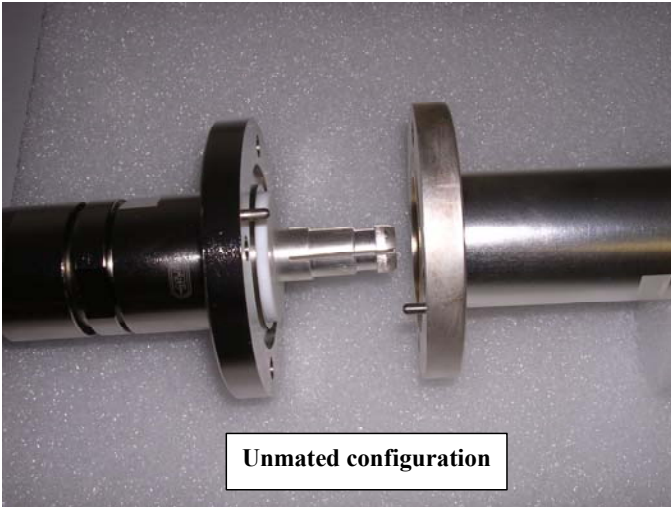
Figure 2

- After every 10 cycles (up to 100), then every 25 (up to 200), then every 50 (up to 500) all-electrical / mechanical test & inspections performed at baseline were repeated on each sample. See figures 2-3 for mating configurations.

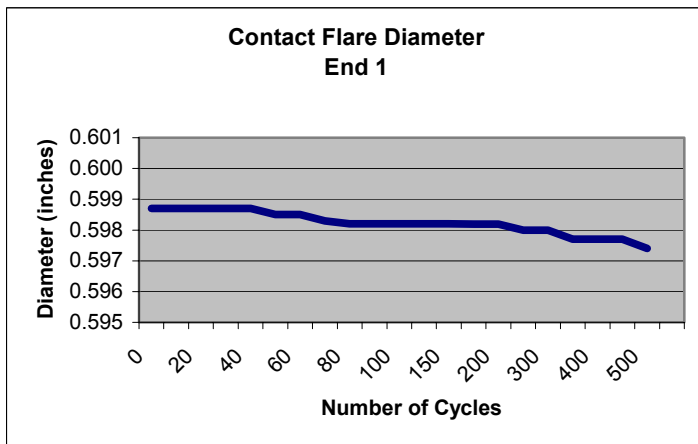
Figure 4

Contact Flare diameter measurements

- TRU 1-5/8 EIA meet /exceed 500 mating cycles, without any significant degradation to electrical / mechanical performance parameters. The test results were summarized and recorded per the following data: See figures 4-8.
- The VSWR and contact flare diameter following the extended mate test revealed little to no change.
- There was significant plating wear on the contact (see figures 9-11), but this did not affect electrical performance. The first signs of plating wear noticed after 60 cycles.

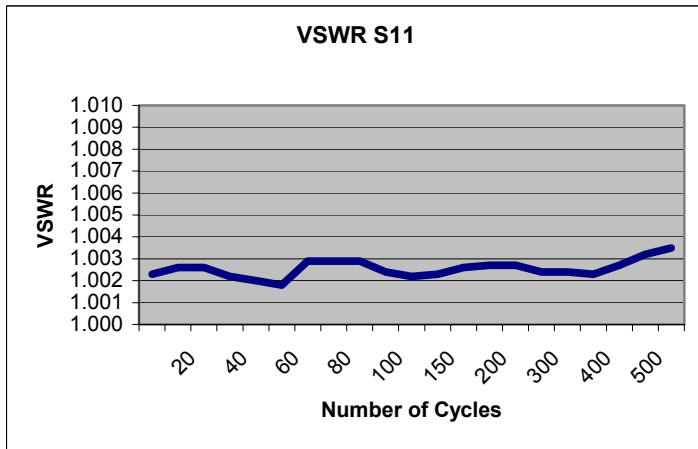
Figure 6

VSWR measurements

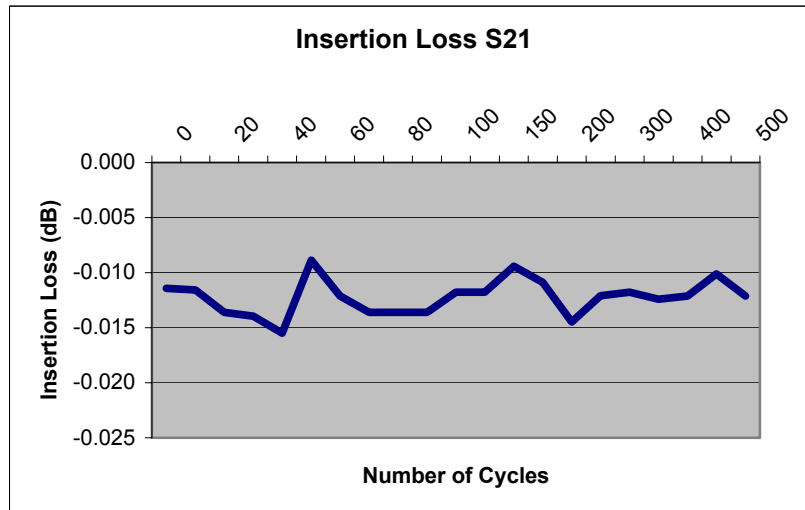
Figure 8

Insertion loss measurements
